FOURTH QUARTERLY REPORT

Project Title: *Determining Integrity Reassessment Intervals through Corrosion Rate Modeling and Monitoring*

Prepared by: *Southwest Research Institute*

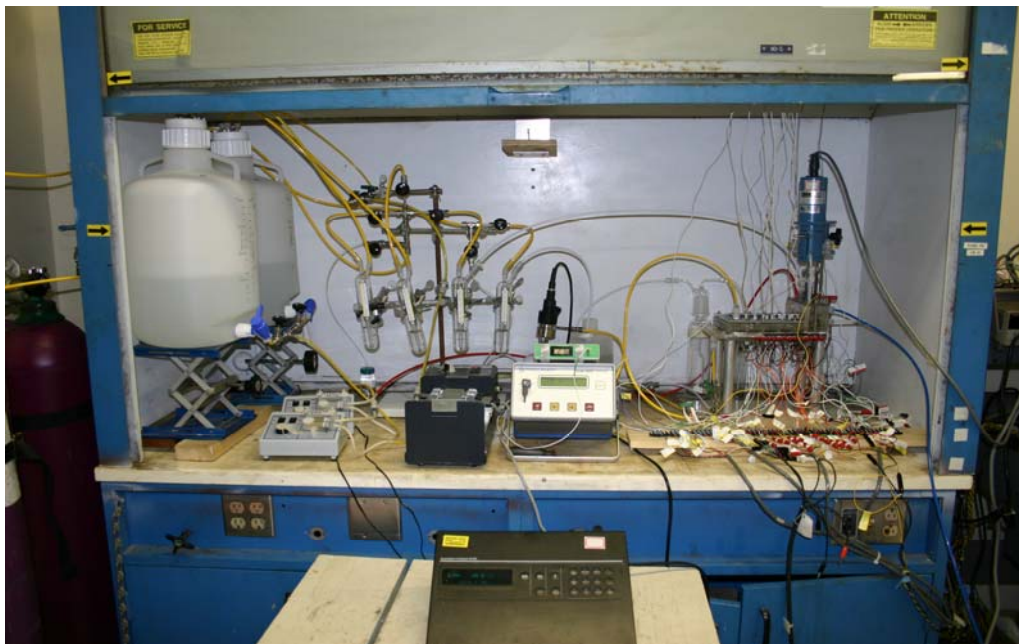
Figure 1. Overall view of the experimental apparatus. The data acquisition system is not shown in this picture.

One of the common occurrences of external corrosion is the flow of groundwater through a holiday in the coating in to a disbonded area, the water exiting through another holiday located elsewhere in the coating. In a spiral-wrapped tape coating, the flow can occur all around the pipe at the overlap between wraps. The disbonded coating modeling and experiments published in the literature have not involved flow of solution through the disbonded region. Therefore, experimental apparatus was constructed to determine the effect of controlled flow and compare to model predictions. The overall view of the apparatus is shown in Figure 1.
